Manhole Inspection Summary

Manhole # S35W__051MH

Insp Date: **3/4/08 1:45 PM**

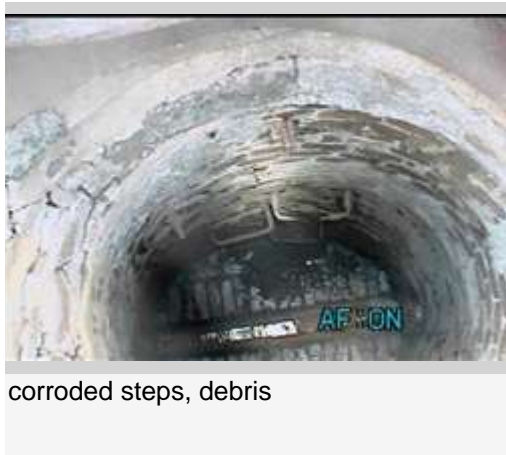
Defect 2

Steps Count: **5** Missing: **3** ☒ **Corroded**

corroded steps, debris

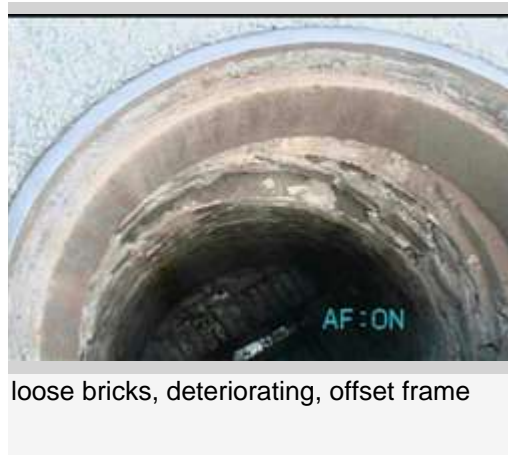
Defect 1

Frame Offset: **3** (in.) Condition: ☒ Sound ☐ Cracked ☐ Leaks

Condition: ☐ Sound ☐ Cracked ☐ Root Intrusion ☒ **Loose Brick** ☒ **Deteriorated**

Infiltration: ☐ None ☐ Joint ☒ **Cracks** ☐ Mortar ☐ Roots ☐ Wall

loose bricks, deteriorating, offset frame

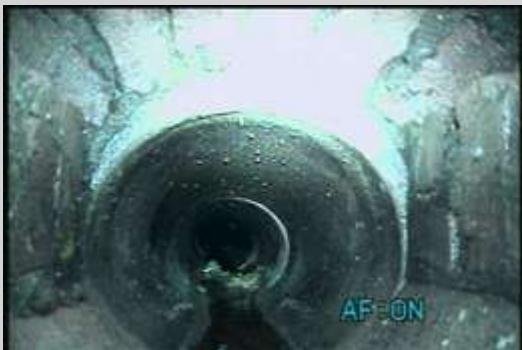
12 O'Clock Outflow

8 in. Circular Gravity Sewer
Pipe Out @ 12 OClock

Pipe Height: **0** (in.) Direct
Pipe Material: **Clay** ☐ Pipe Lined
Invert Depth: **9.80** (ft.) Flow Characteristics: **Fast**
Deposits: ☒ None ☐ Mud ☐ Sludge ☐ Debris ☐ Grease
Silt Depth: **0** (in.) Deposits Extent:
Infiltration: **None** Pipe Seal Cond: **Unknown**

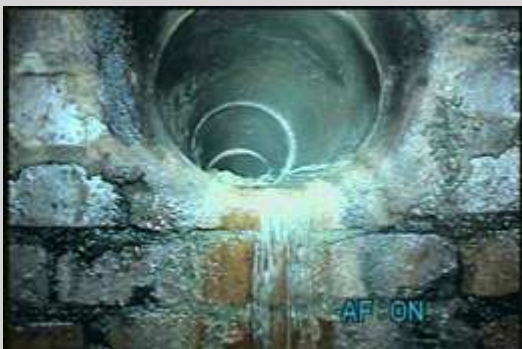
6 O'Clock Inflow

8 in. Circular Gravity Sewer
Pipe In @ 6 OClock

Pipe Height: **0** (in.) Direct
Pipe Material: **Clay** ☐ Pipe Lined
Invert Depth: **7.50** (ft.) Flow Characteristics: **Fast**
Deposits: ☒ None ☐ Mud ☐ Sludge ☐ Debris ☐ Grease
Silt Depth: **0** (in.) Deposits Extent:
Infiltration: **None** Pipe Seal Cond: **Unknown**

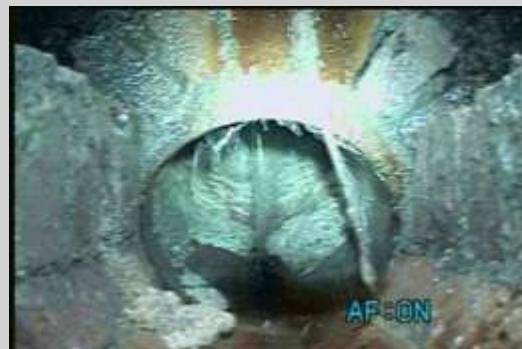
Drop In @ 6 OClock

Drop: **Inside** **Direct**
Angled: Reading: **0.00** (ft.)
Inv Depth: **9.70** (ft.)
Drop Condition: **Open**
